FINAL REPORT  
for  
OTEC RAISER CABLE AT  
PUNTA TUNA, PUERTO RICO

OTEC RAISER CABLE AT  
PUNTA TUNA, PUERTO RICO

SIMPLEX WIRE AND CABLE COMPANY  
P.O. Box 479  
Portsmouth, New Hampshire 03801

The racks were deployed on 13 and 14 May 1980. Inspections of the samples and of the lines which supported the racks were made on 25 June, 4 August, 10 September, 31 October 1980, and 20 & 21 January 1981. The racks were not redeployed following the January 1981 inspection since DOE funding for the research platform was terminated. A report on the 25 June inspection was sent to Simplex on 16 July 1980. Since CEER received no funding from Simplex during the summer, no reports on the August and September inspections were submitted. This final report includes inspection forms and photographs from the October, 1980 and January, 1981 inspections.

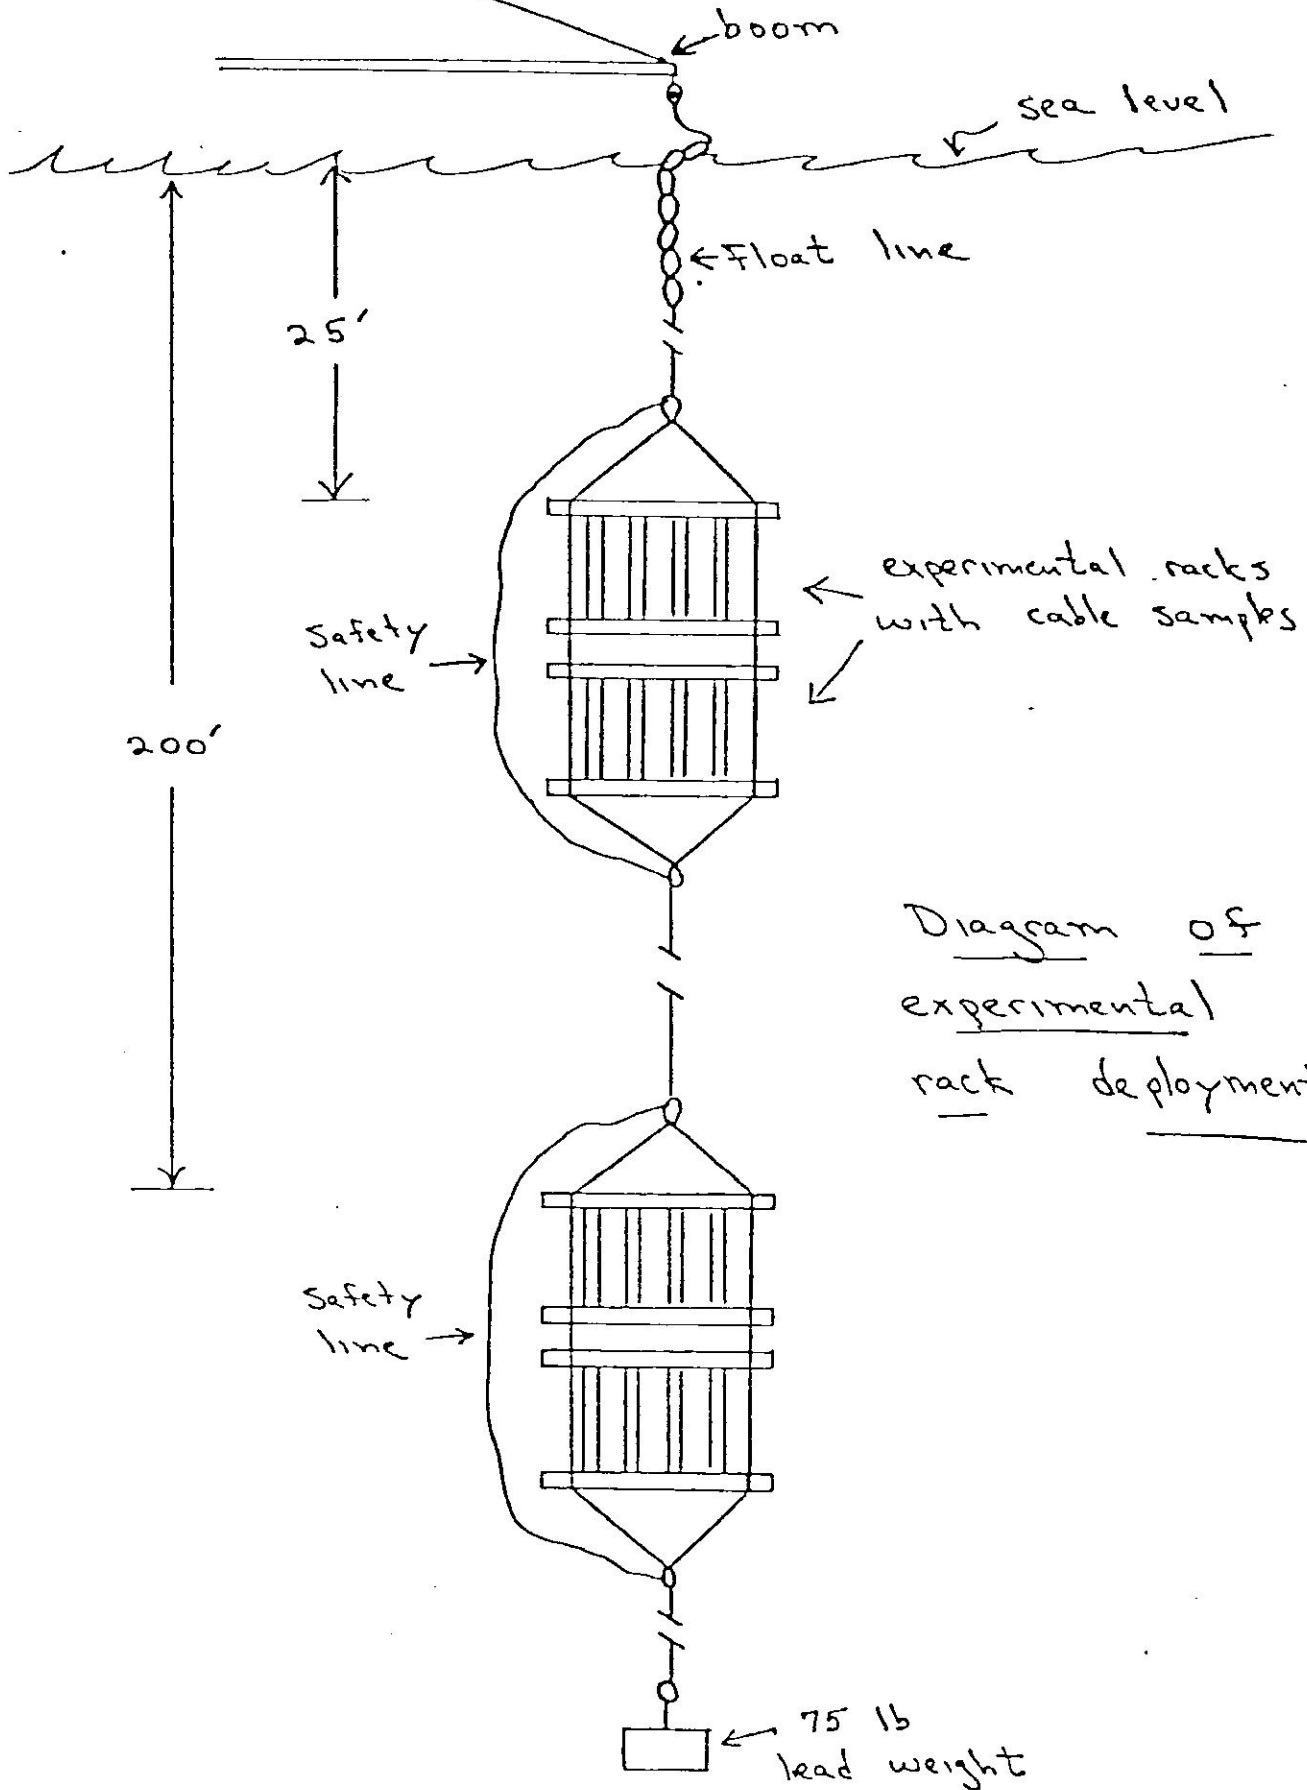
Figure 2 Diagram of experimental  
rack deployment

Four sets of racks, each containing the eight coverings to be tested, were deployed from two different lines. Each line had one set of racks at a depth of 25 feet and one set of racks at a depth of 200 feet (Fig. 2). The arrangement of the samples on the racks is shown in figure 3.

Diagram of experimental rack deployment

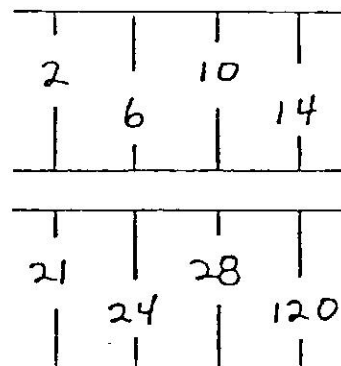
Figure 3 Arrangement of cable samples  
on experimental racks.

Arrangement of cable samples on  
experimental racks

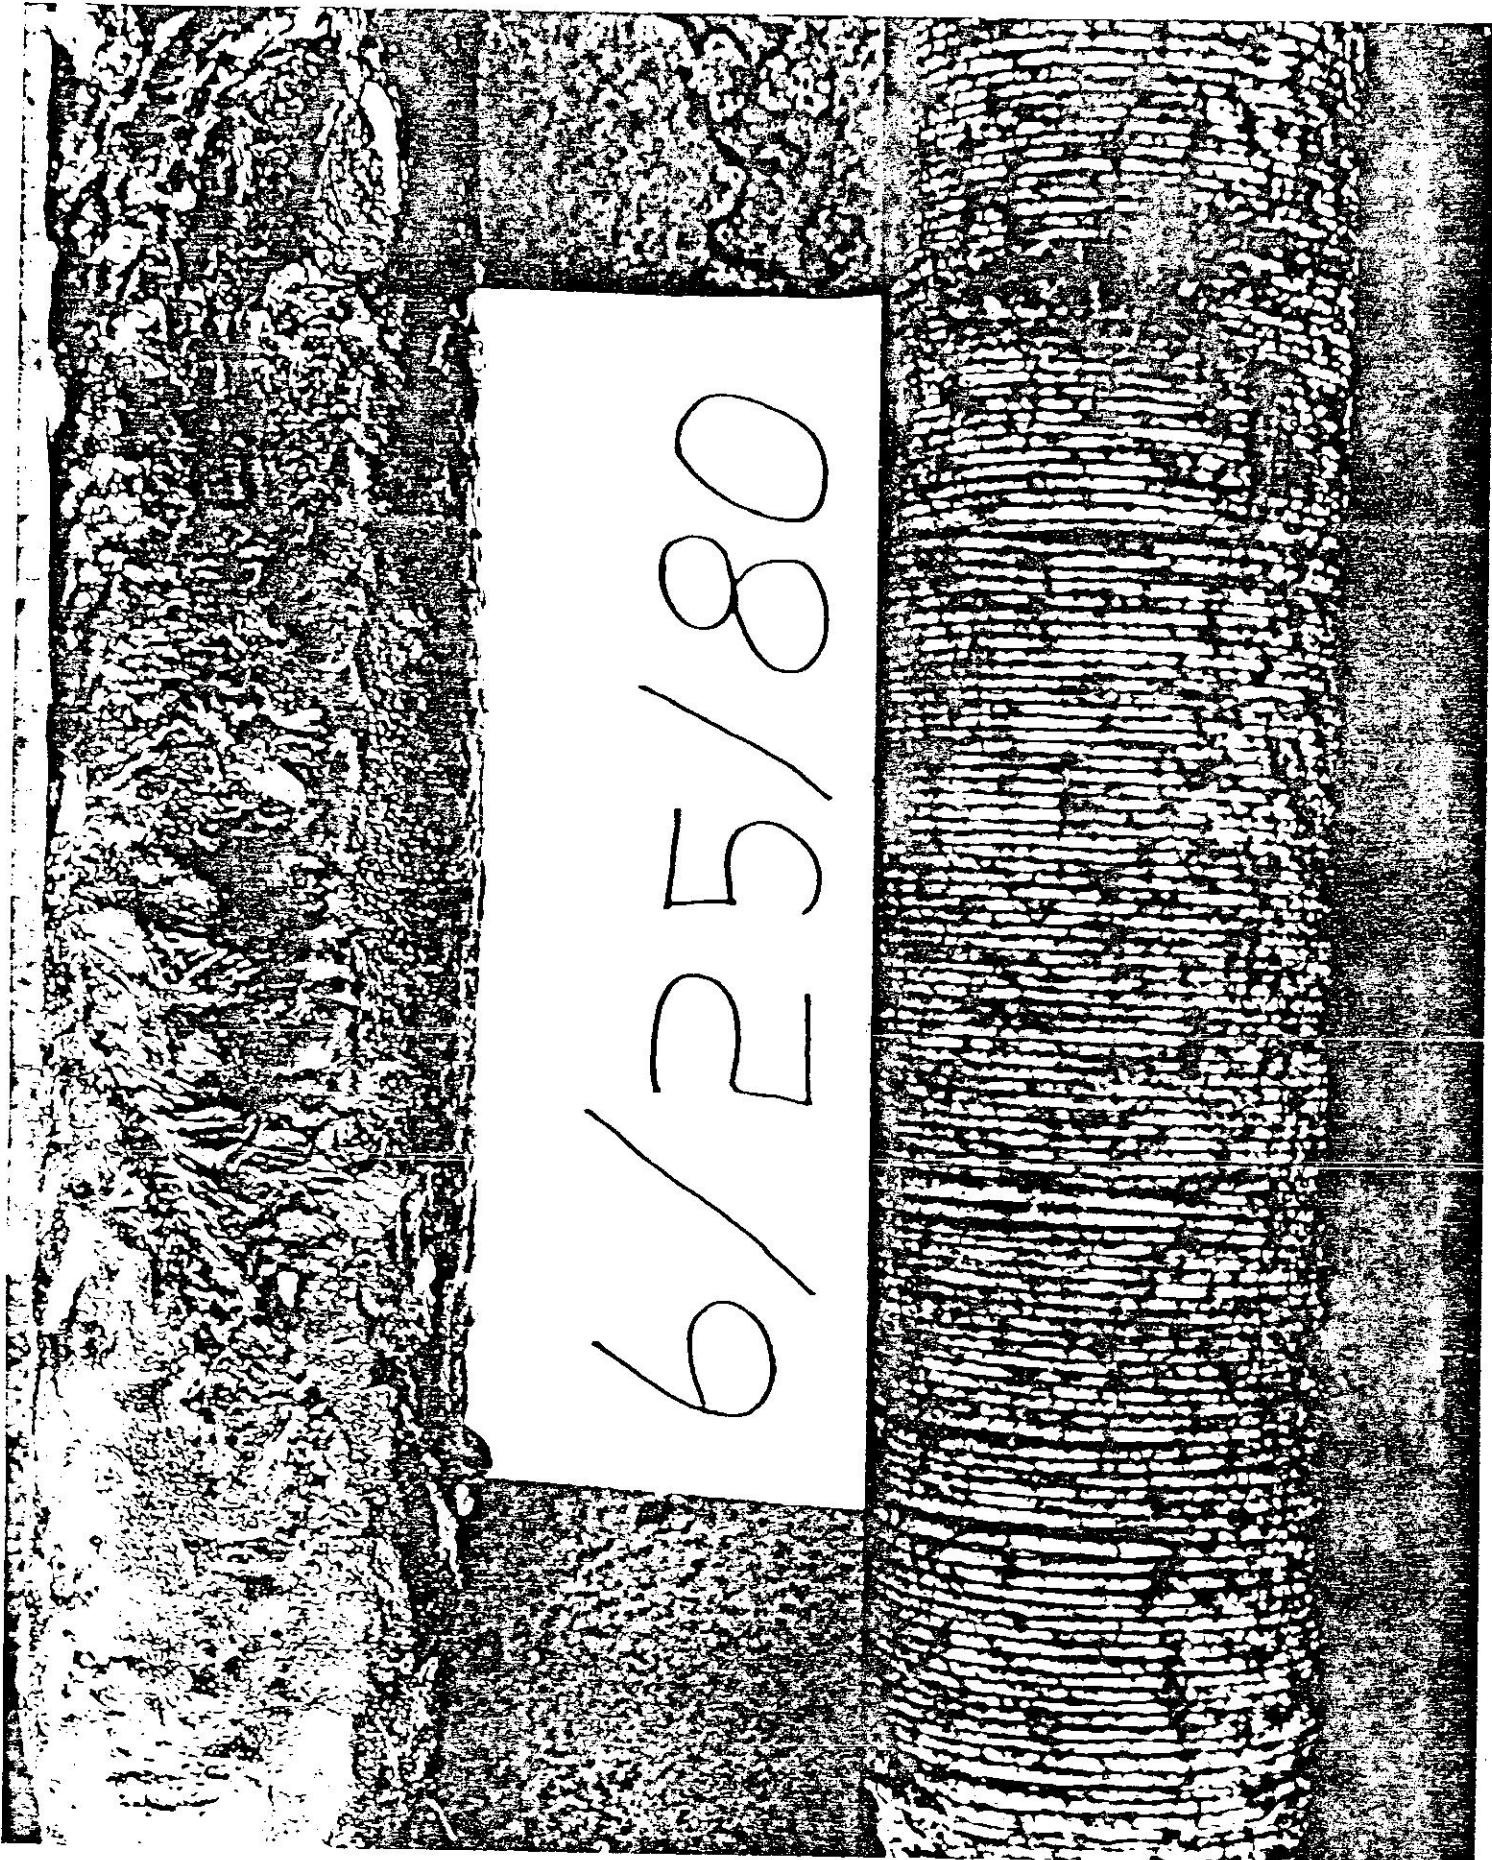
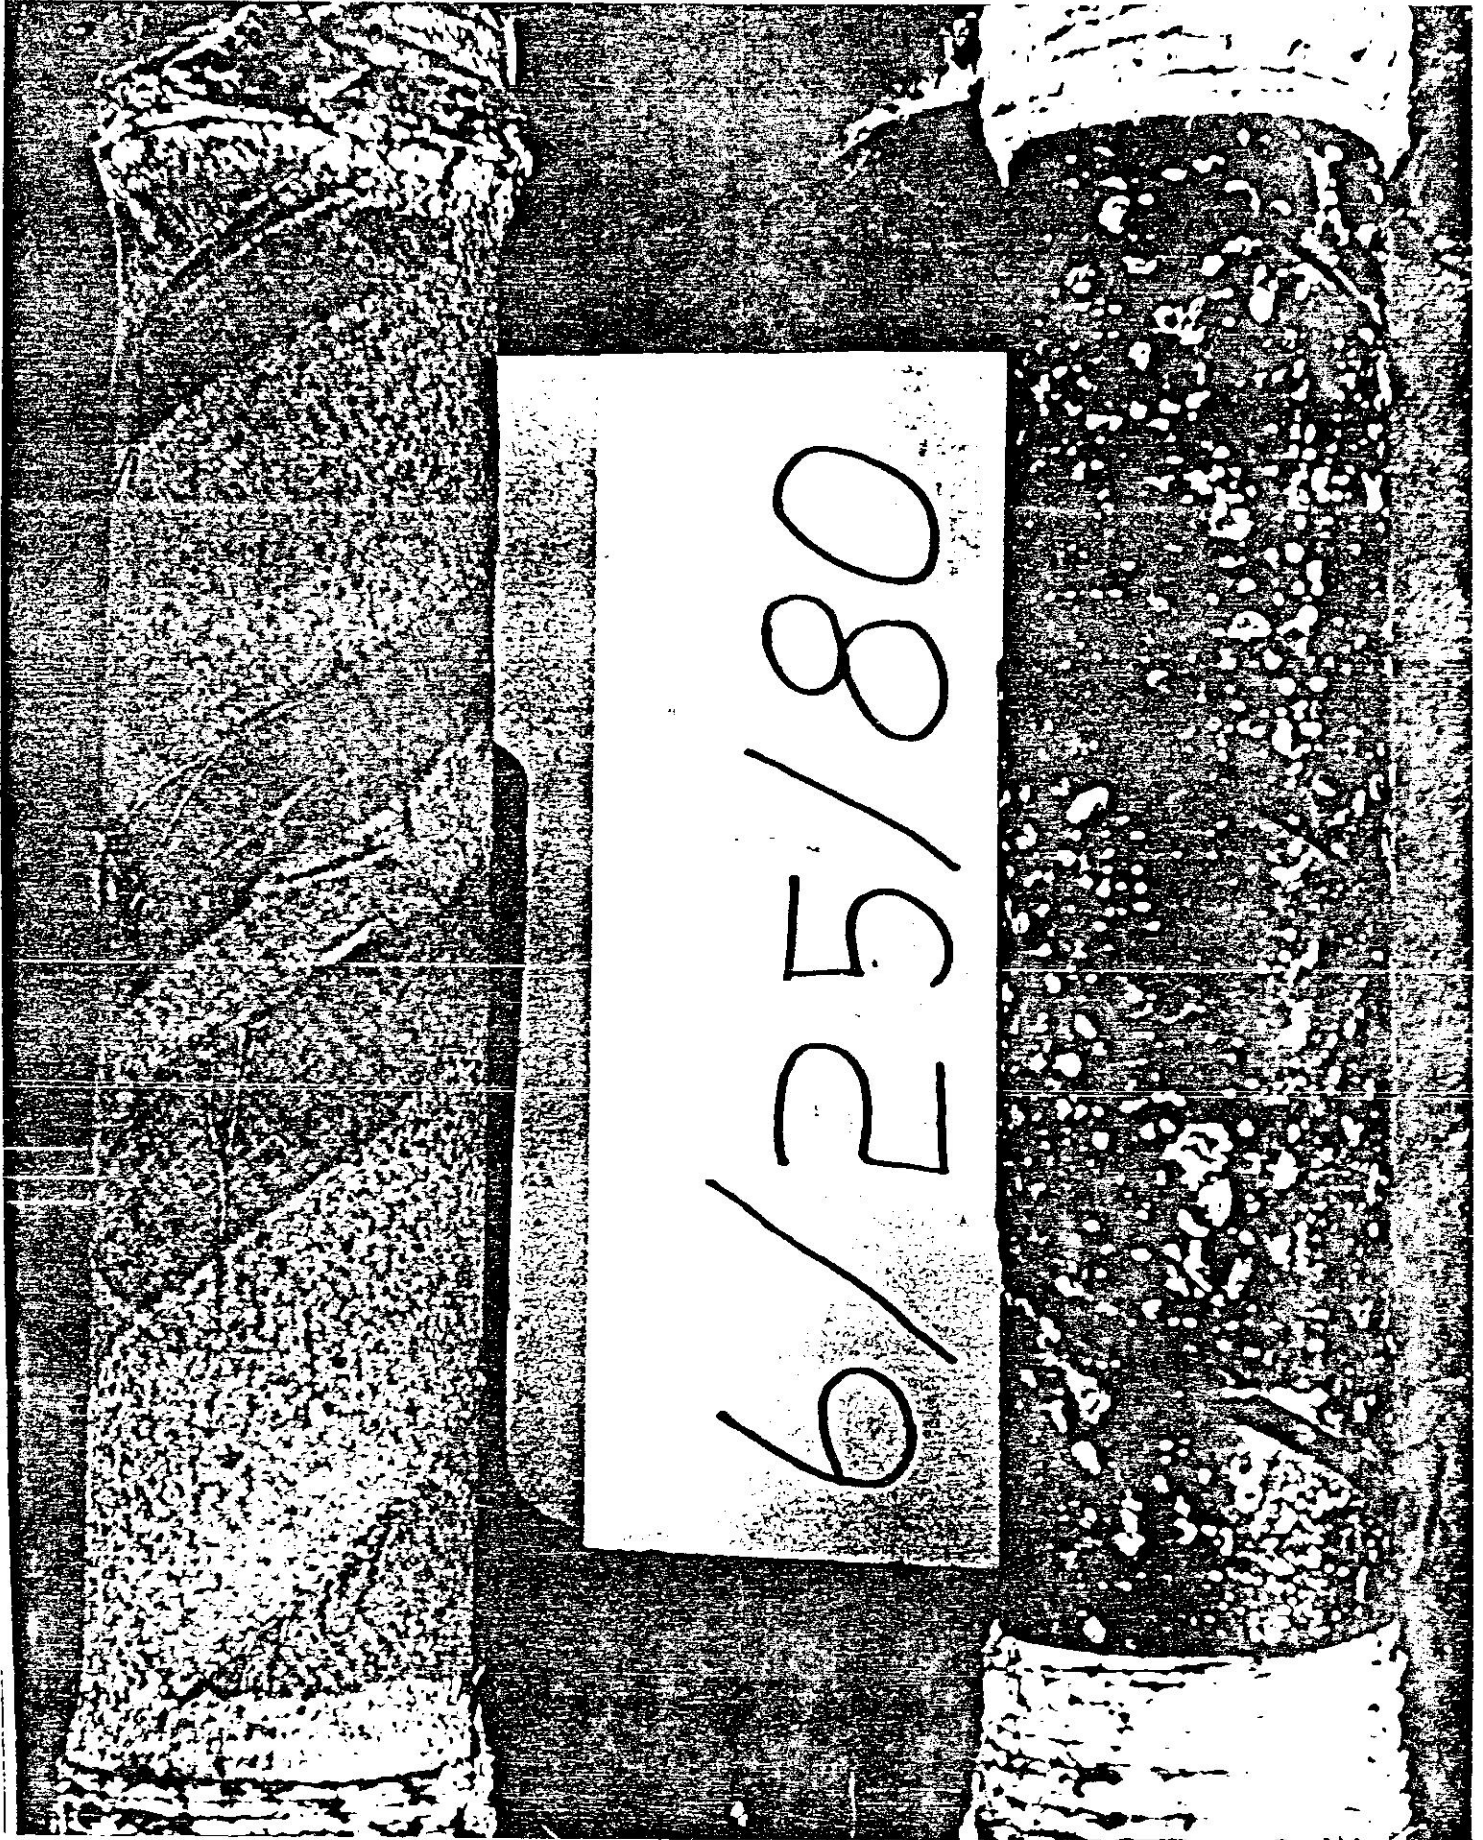
SAMPLE #	EROSION	CORROSION	BIOFOULING
3	NONE	NONE	Hydroids (<5% cover)
7	NONE	NONE	Hydroid (30% cover)
11	NONE	NONE	Hydroid (5-10% cover)
15	NONE	NONE	Hydroid (50% cover)
18	NONE	Superficial Some oxidation	NONE
22	NONE	Slight corrosion at seams	NONE
25	NONE	NONE	Hydroid (50% cover)
117	NONE	NONE	Hydroid (50% cover)

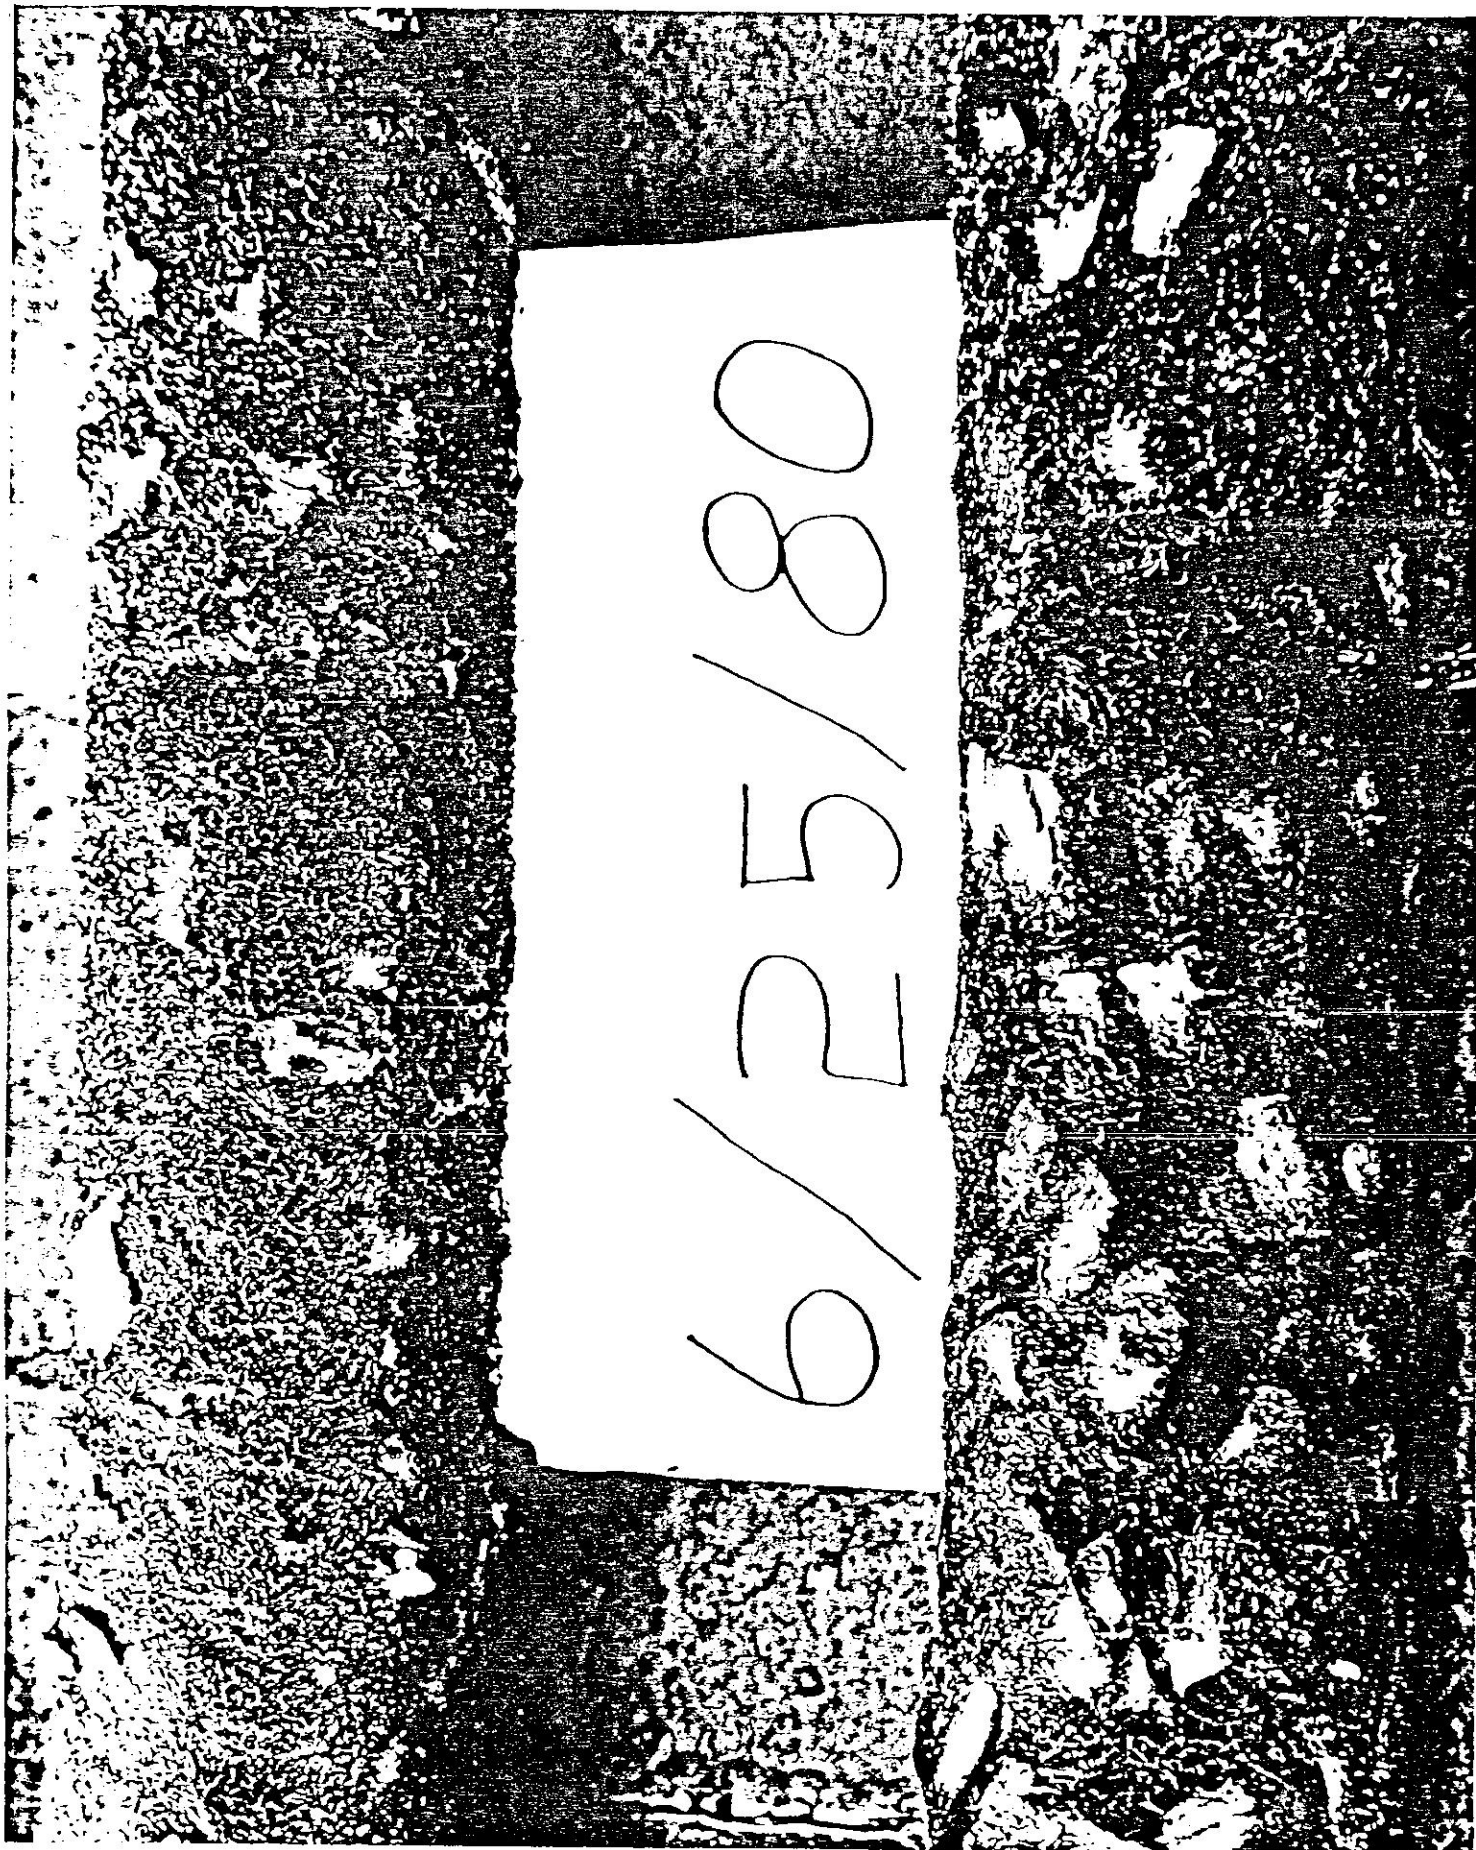
SAMPLE #	EROSION	CORROSION	BIOFOULING
1	NONE	NONE	Hydroids (50% cover) Amphipods (numerous)
5	NONE	NONE	Hydroids (50% cover) Amphipods (numerous)
9	NONE	NONE	Hydroids (70% cover) Amphipods (numerous) Polychaete (13)
13	NONE	NONE	Hydroids (70% cover) Amphipods (numerous) Polychaete (13)
17	NONE	Some superficial oxidation	NONE
20	NONE	Slight corrosion at seams	Hydroids (5-10% cover)
26	NONE	NONE	Hydroids (70% cover) Macro-algae (<1% cover) Amphipods (numerous)
118	NONE	NONE	Hydroids (70% cover) Macro-algae (<1% cover) Amphipods (numerous)

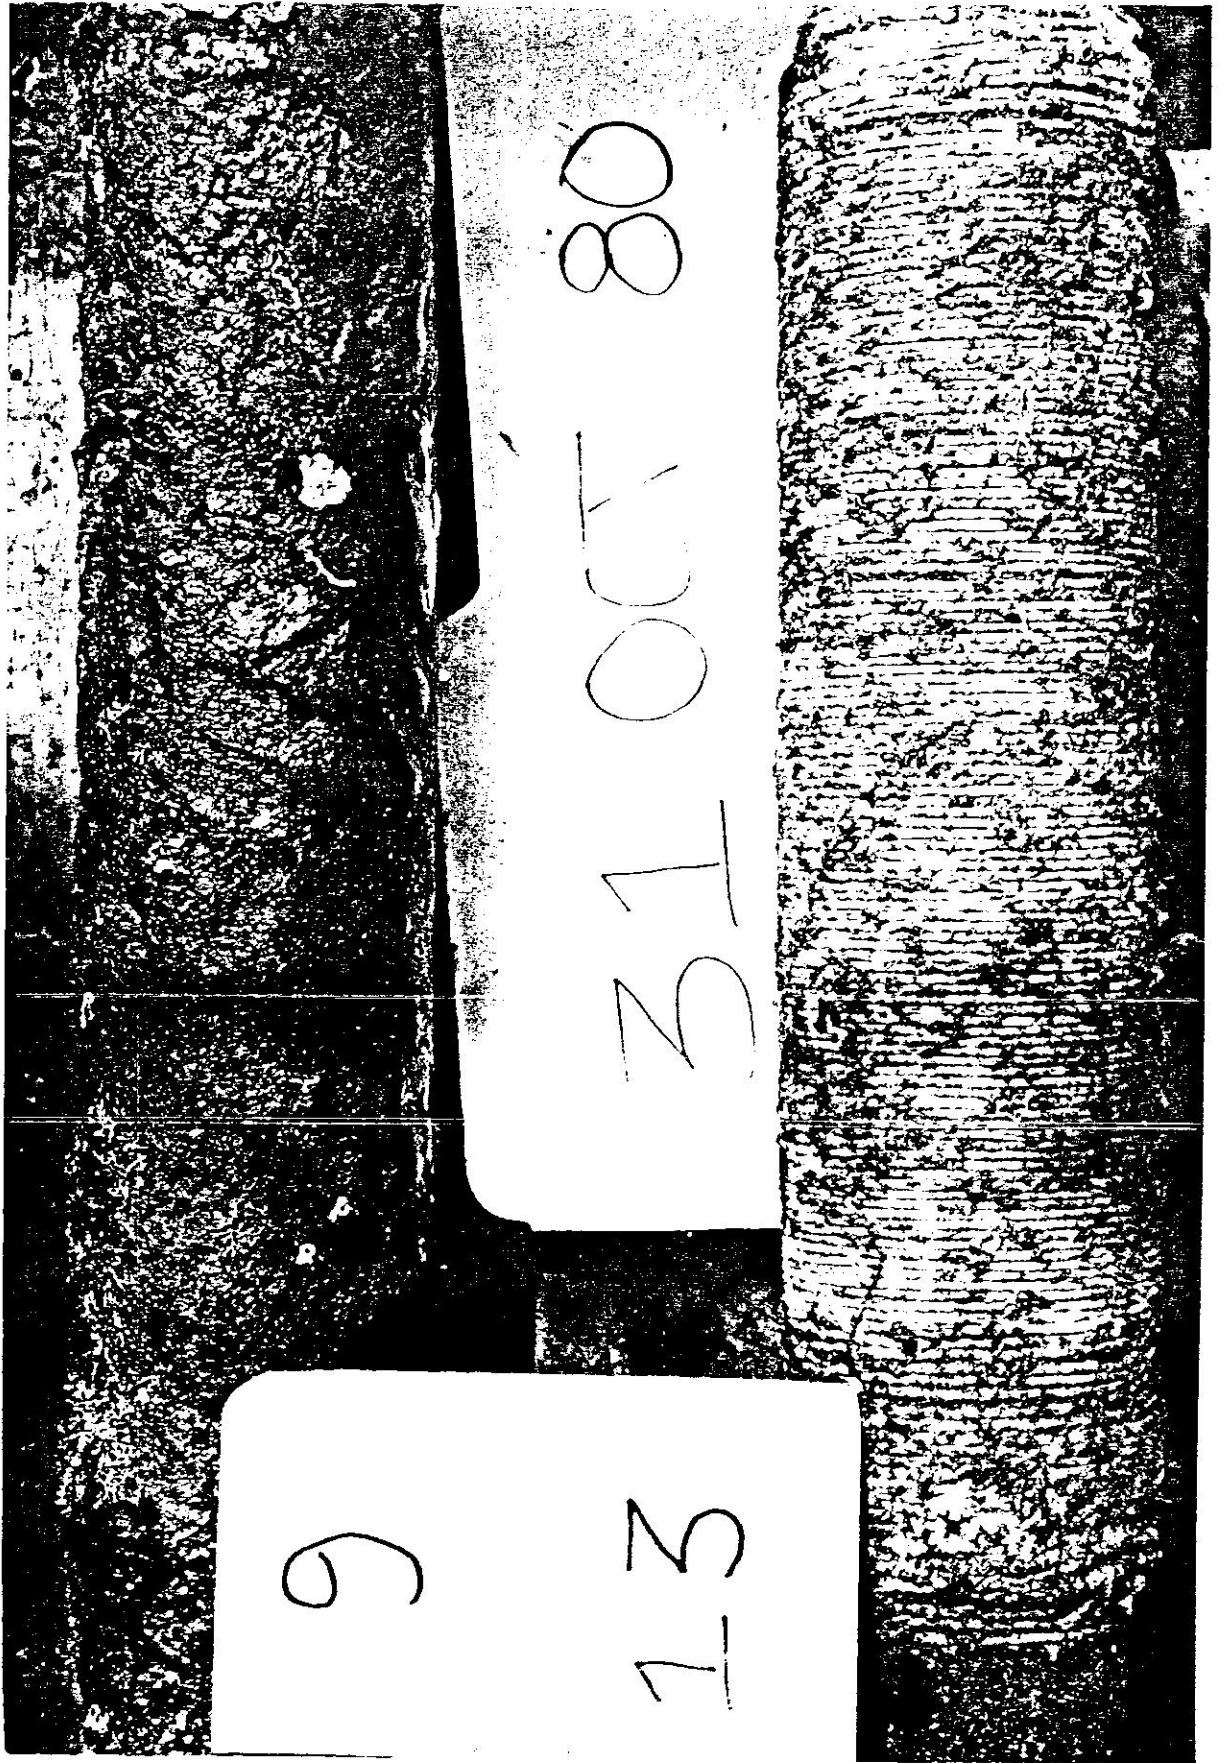
SAMPLE #	EROSION	CORROSION	BIOFOULING
1	None	None	See Detailed Analysis
5	None	None	" " "
9	None	None	" " "
13	None	None	" " "
17	None	shallow pitting	None
20	None	cover gone - shallow pitting	None
26	None	None	See Detailed Analysis
118	None	None	" " "

algae	80 % cover
<u>Cladophora</u>	algae dominant
<u>Microcoleus</u>	
<u>Polysiphonia</u>	
bryozoan	
ascidian	
<u>Diplosoma</u>	
hydroid	
<u>Plumularia</u>	
anemone	occasional
<u>Aiptasiogeton</u>	
serpulid worm	several per sample
<u>Filograna</u>	
<u>Hydroides</u>	
bivalve	occasional
<u>Pinctada</u>	
amphipod	numerous
<u>Podocerus</u>	
<u>Stenothoe</u>

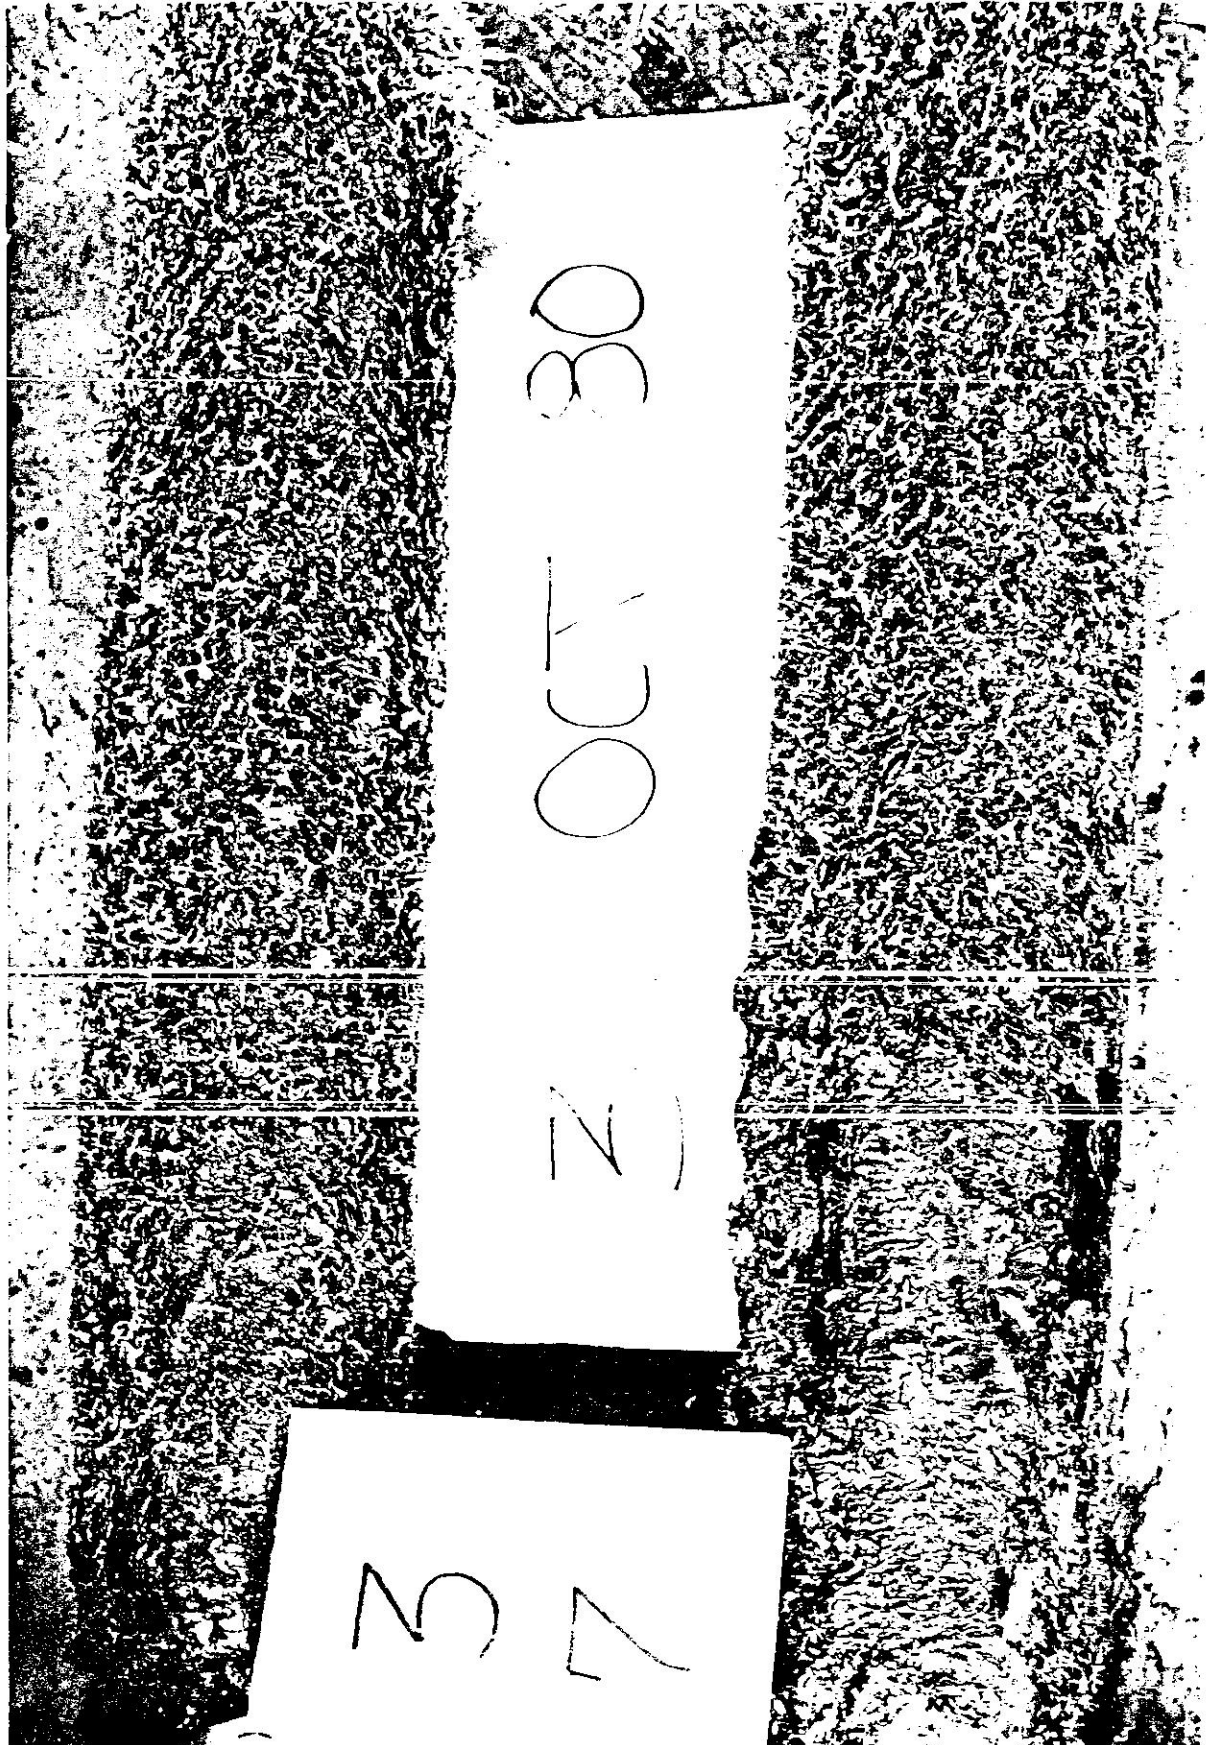
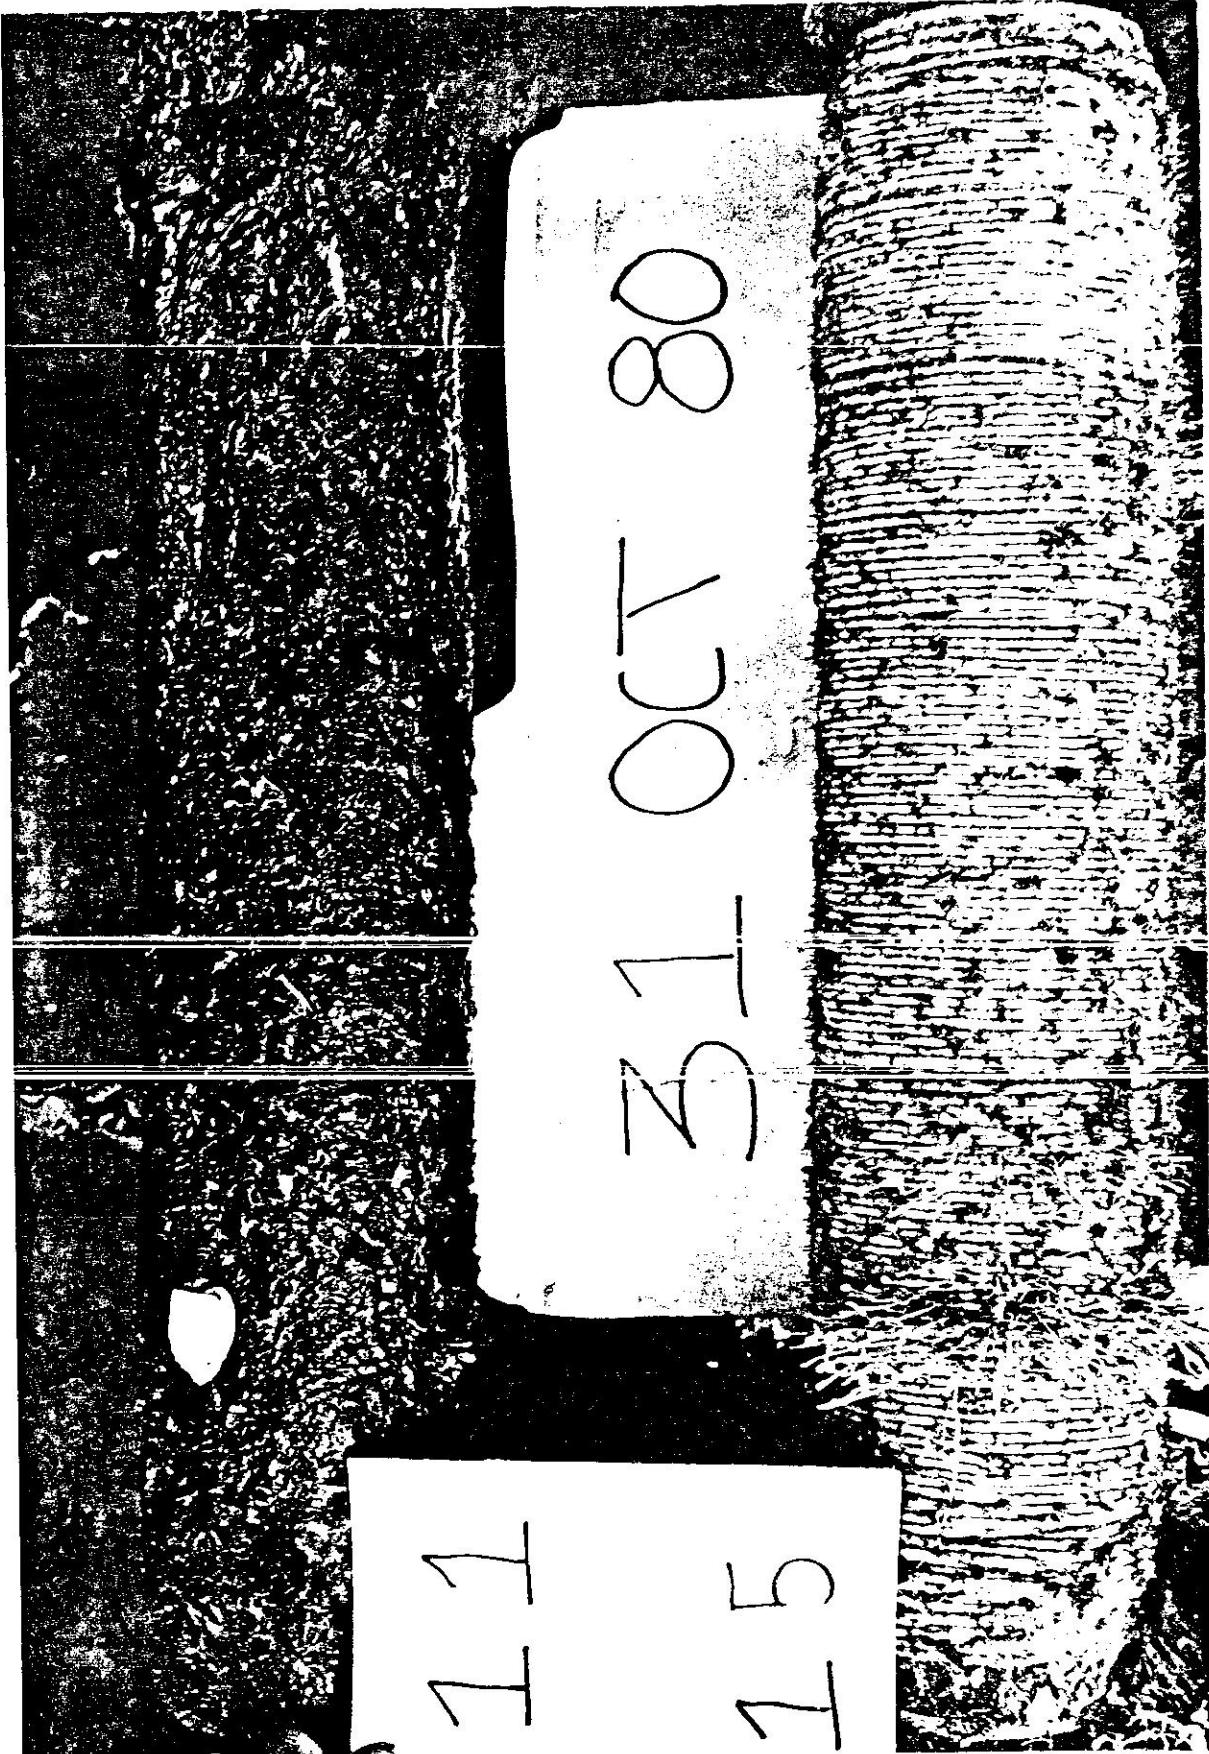
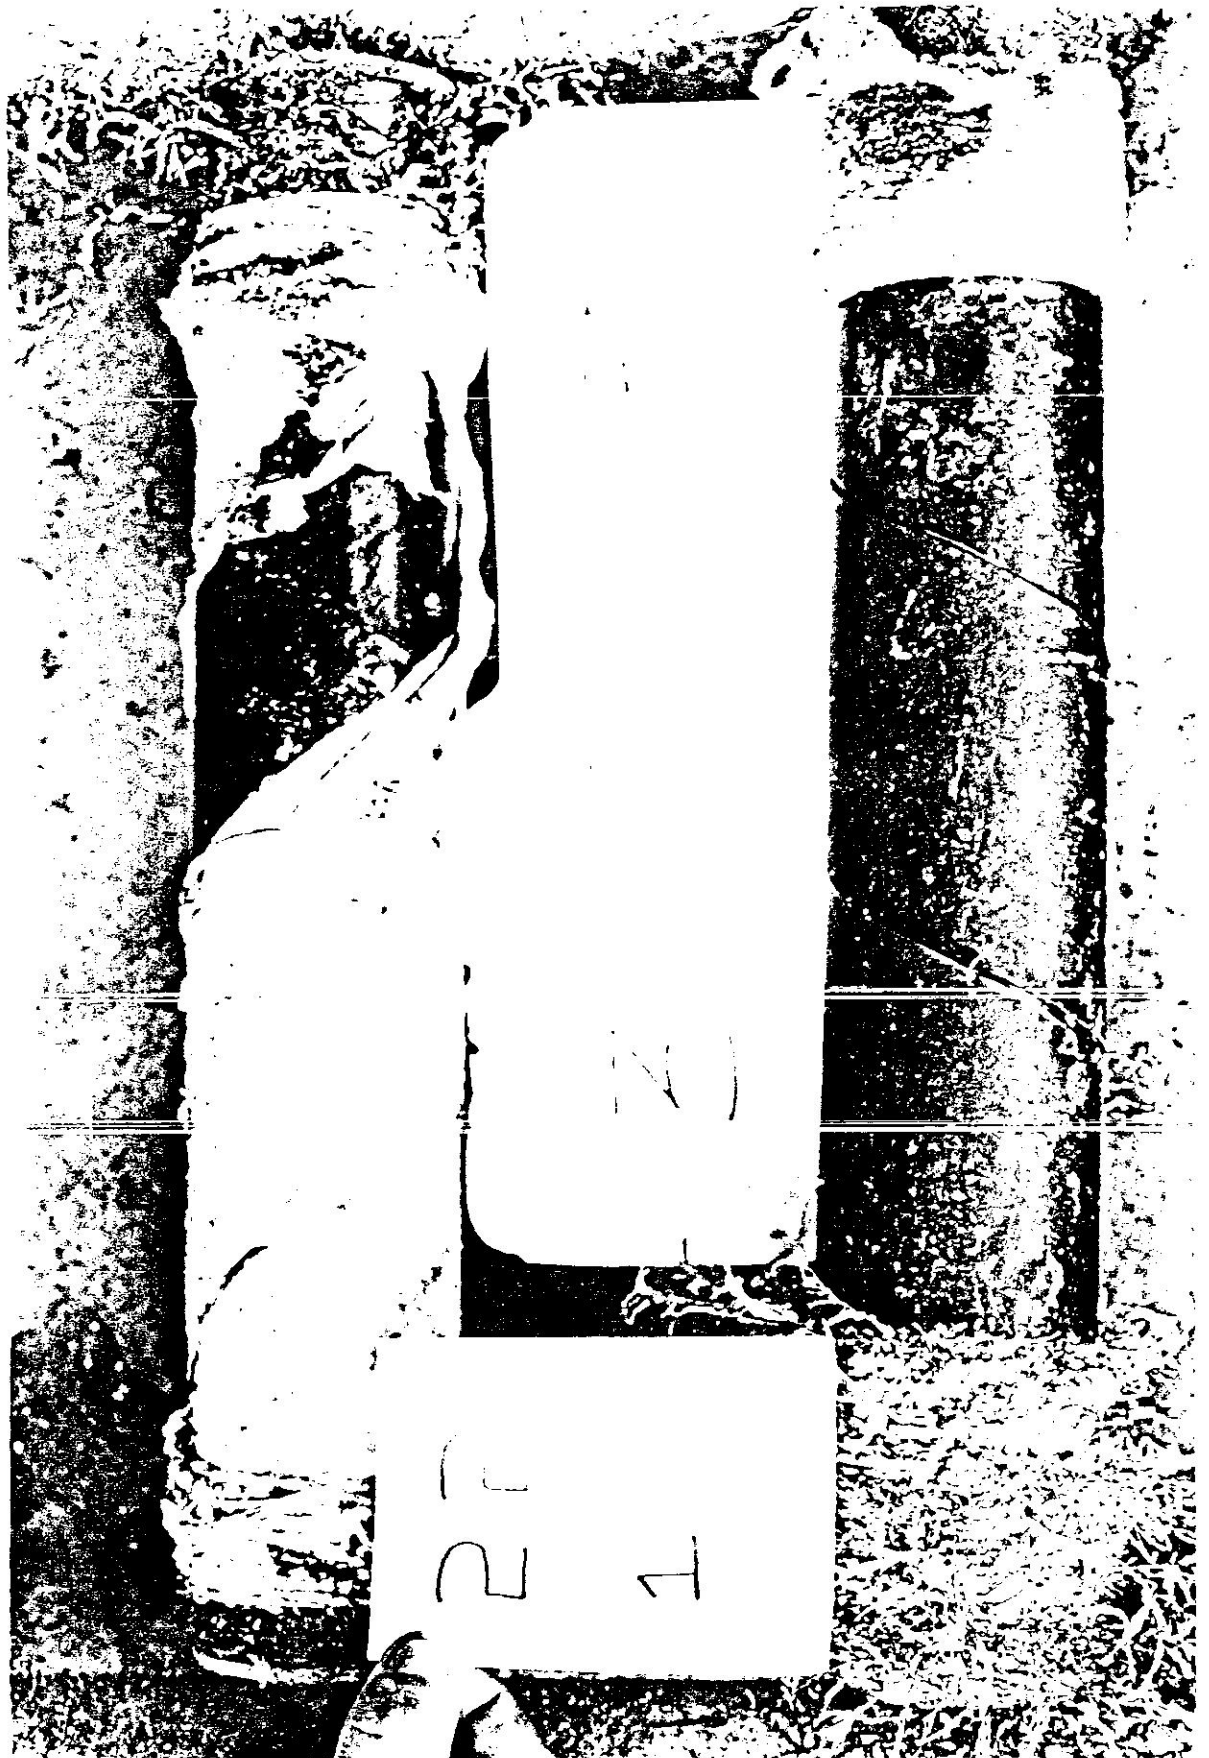
SAMPLE #	EROSION	CORROSION	BIOFOULING
3	None	None	A 80% cover C few D numerous
7	None	None	A 80% cover C few D numerous
11	None	None	A 20% cover C few D few E 1
15	None	None	A 60% cover B < 5% cover C few D numerous
18	None	shallow pitting	A in crevice
22	None	Cover torn shallow pitting	
25	None	None	A 80% cover C few D numerous
117	None	None	A 60% cover C few D numerous

A. hydroid Obelia  
 B. hydroid Halocordyle  
 C. Serpulid worm Hydroides, Filograna  
 D. amphipod Podocerus, Stenothoe, caprellid  
 E. gooseneck barnacle Lepas
