FINAL REPORT  
for  
OTEC RAISER CABLE AT  
PUNTA TUNA, PUERTO RICO

OTEC RAISER CABLE AT  
PUNTA TUNA, PUERTO RICO

SIMPLEX WIRE AND CABLE COMPANY  
P.O. Box 479  
Portsmouth, New Hampshire 03801

The racks were deployed on 13 and 14 May 1980. Inspections of the samples and of the lines which supported the racks were made on 25 June, 4 August, 10 September, 31 October 1980, and 20 & 21 January 1981. The racks were not redeployed following the January 1981 inspection since DOE funding for the research platform was terminated. A report on the 25 June inspection was sent to Simplex on 16 July 1980. Since CEER received no funding from Simplex during the summer, no reports on the August and September inspections were submitted. This final report includes inspection forms and photographs from the October, 1980 and January, 1981 inspections.

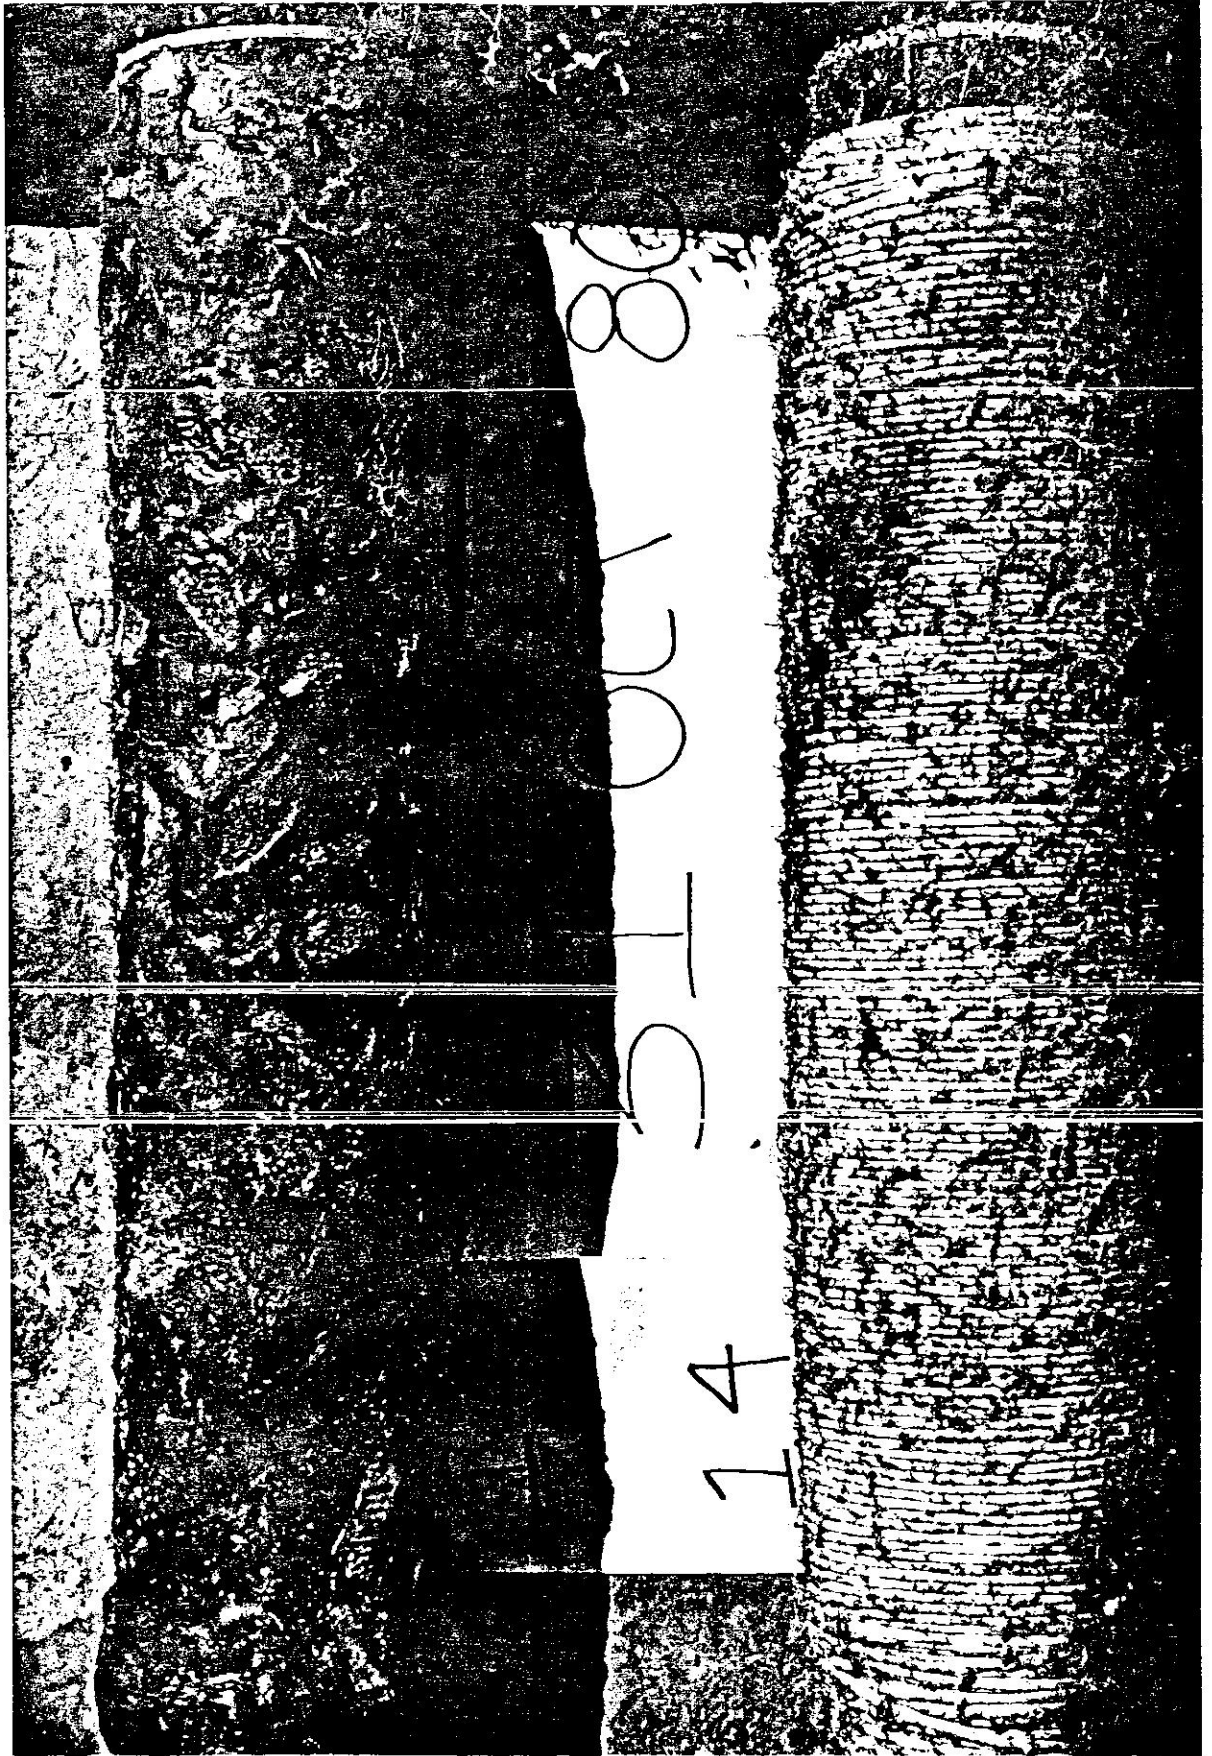
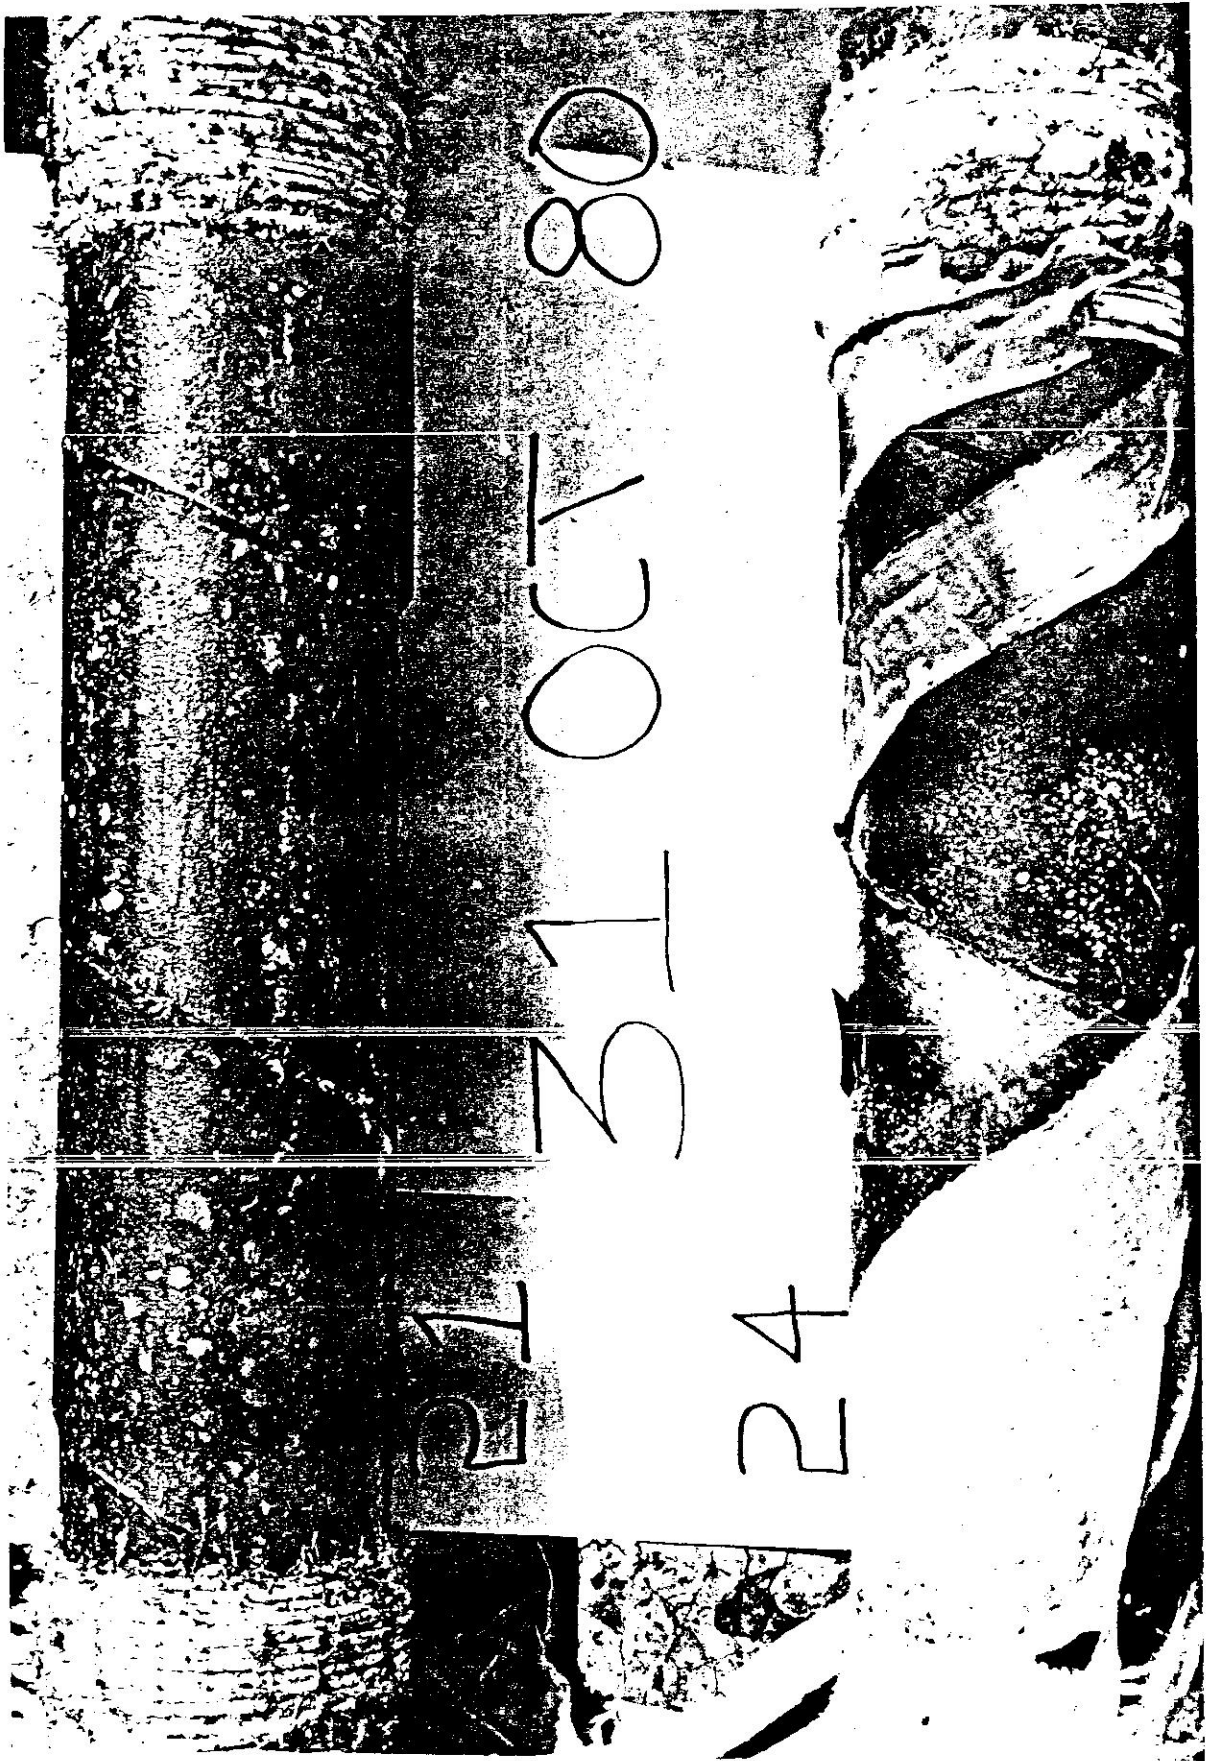
SAMPLE #	EROSION	CORROSION	BIOFOULING
2	None	None	A 80% cover C few D numerous
6	None	None	A 20% cover C few D few E 1
10	None	None	A 20% cover C few D few
14	None	None	A 80% cover C few D numerous
21	None	shallow pitting	C few
24	None	Cover torn shallow pitting	C few
28	None	None	A 20% cover C few D few
120	None	None	A 30% cover B < 1% C few D few

A. hydroid Obelia  
 B. hydroid Halocordyle  
 C. Serpulid worm Hydroides, Filograna  
 D. amphipod Podocerus, Stenothoe, caprellid  
 E. gooseneck barnacle Lepas

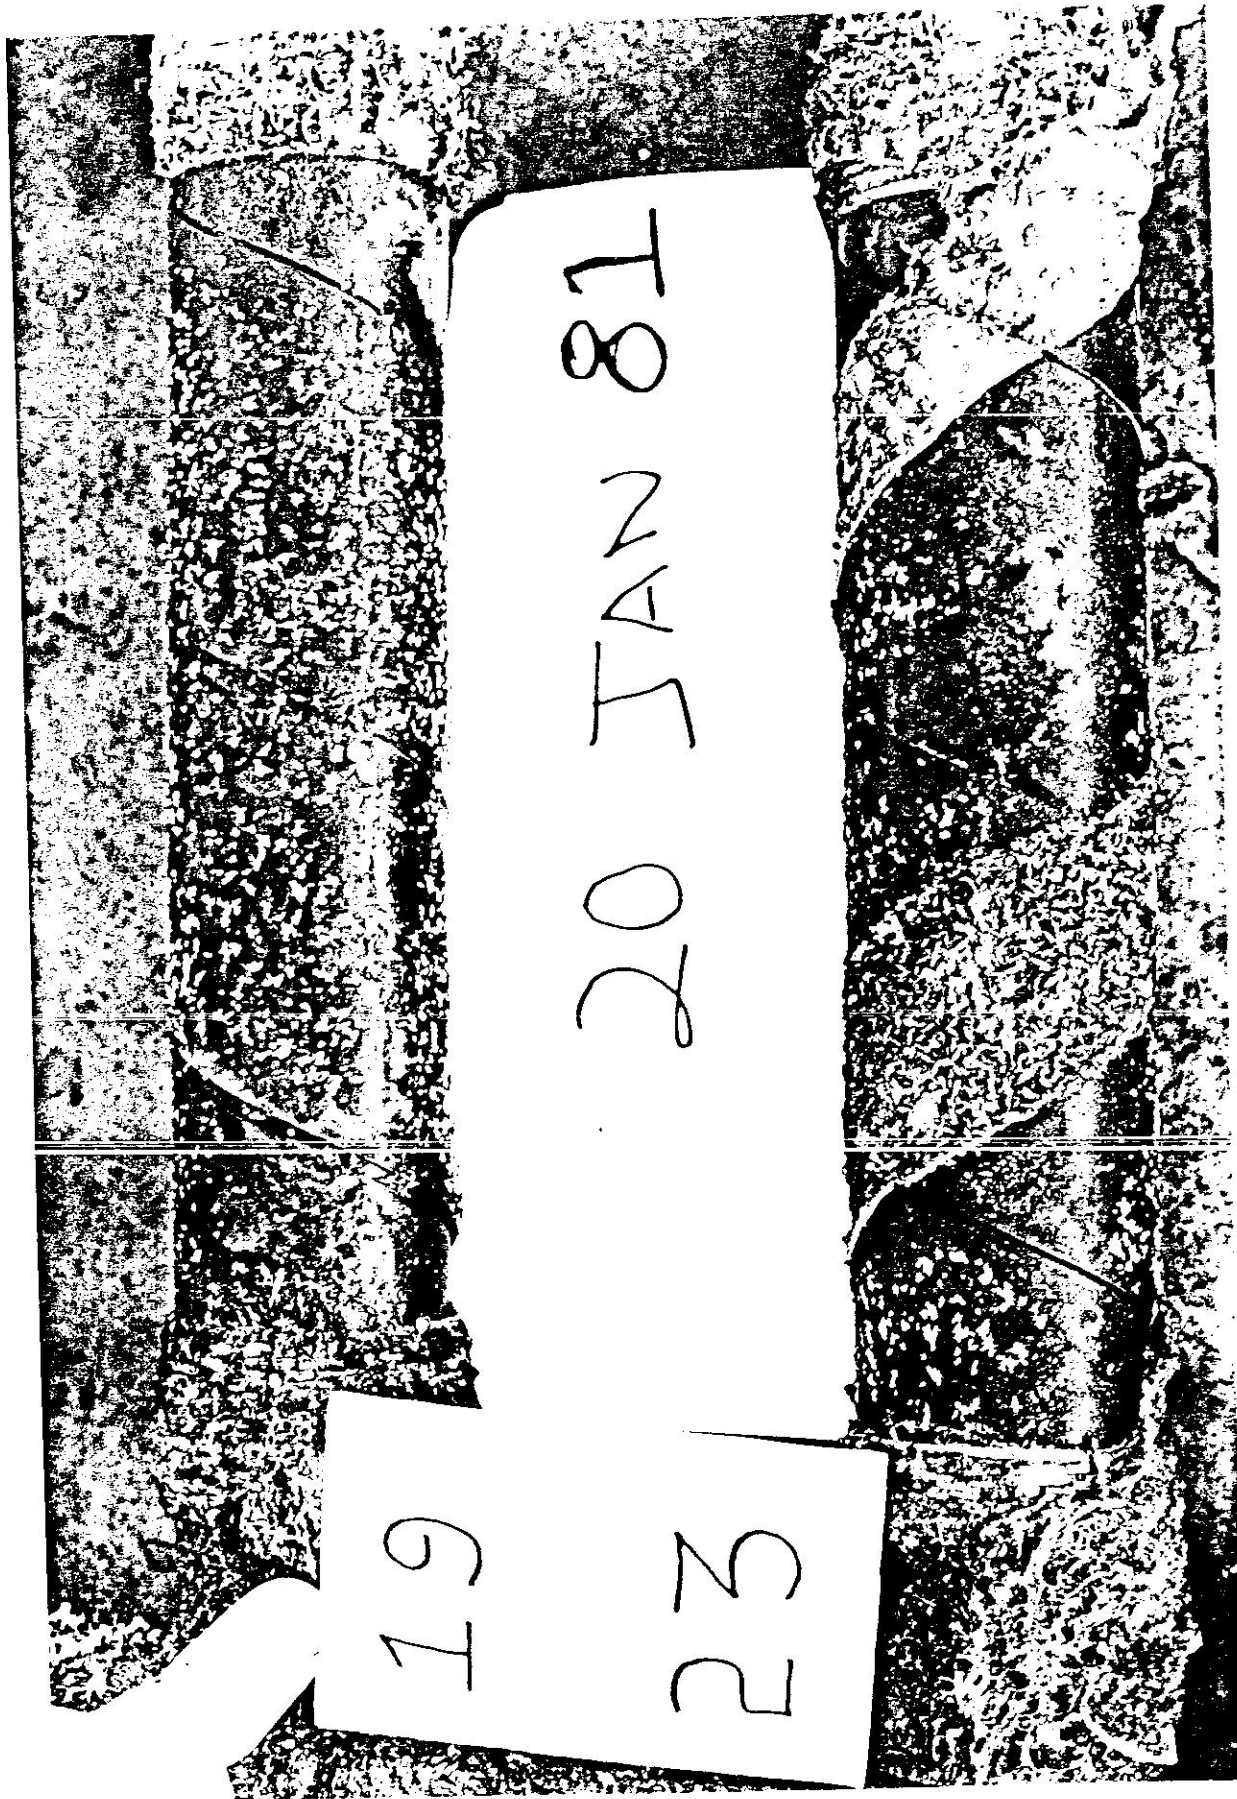
SAMPLE #	EROSION	CORROSION	BIOFOULING
4	None	None	See Detailed Analysis
8	None	None	" " "
12	None	None	" " "
16	None	None	" " "
19	None	considerable pitting	} amphipod (numerous) <u>Podocerus</u> <u>Stenothoe</u>
23	None	cover torn considerable pitting	
27	None	None	See Detailed Analysis
119	None	None	" " "

algae	100 % cover
<u>Antithamnion</u>	algae dominant
<u>Ceramium</u>	
<u>Chondria</u>	
<u>Dasya</u>	
<u>Heterosiphonia</u>	
<u>Microcoleus</u>	
<u>Neomeris</u>	
<u>Polysiphonia</u>	
<u>Spermothamnion</u>	
hydroid	
<u>Plumularia</u>	
bryozoan	
ascidian	
<u>Diplosoma</u>	
sponge	several per sample
<u>Scypha</u>	
anemone	
<u>Aiptasiogeton</u>	
serpulid worm	several per sample
<u>Filograna</u>	
<u>Hydroïdes</u>	
gastropod	several per sample
<u>Alaba</u>	
<u>Cerithium</u>	
bivalve	occasional
<u>Atrina</u>	
<u>Musculus</u>	
amphipod	numerous
<u>Elasmopus</u>	
<u>Podocerus</u>	
<u>Stenothoe</u>	
<u>caprellid</u>	
sipunculid	few per sample

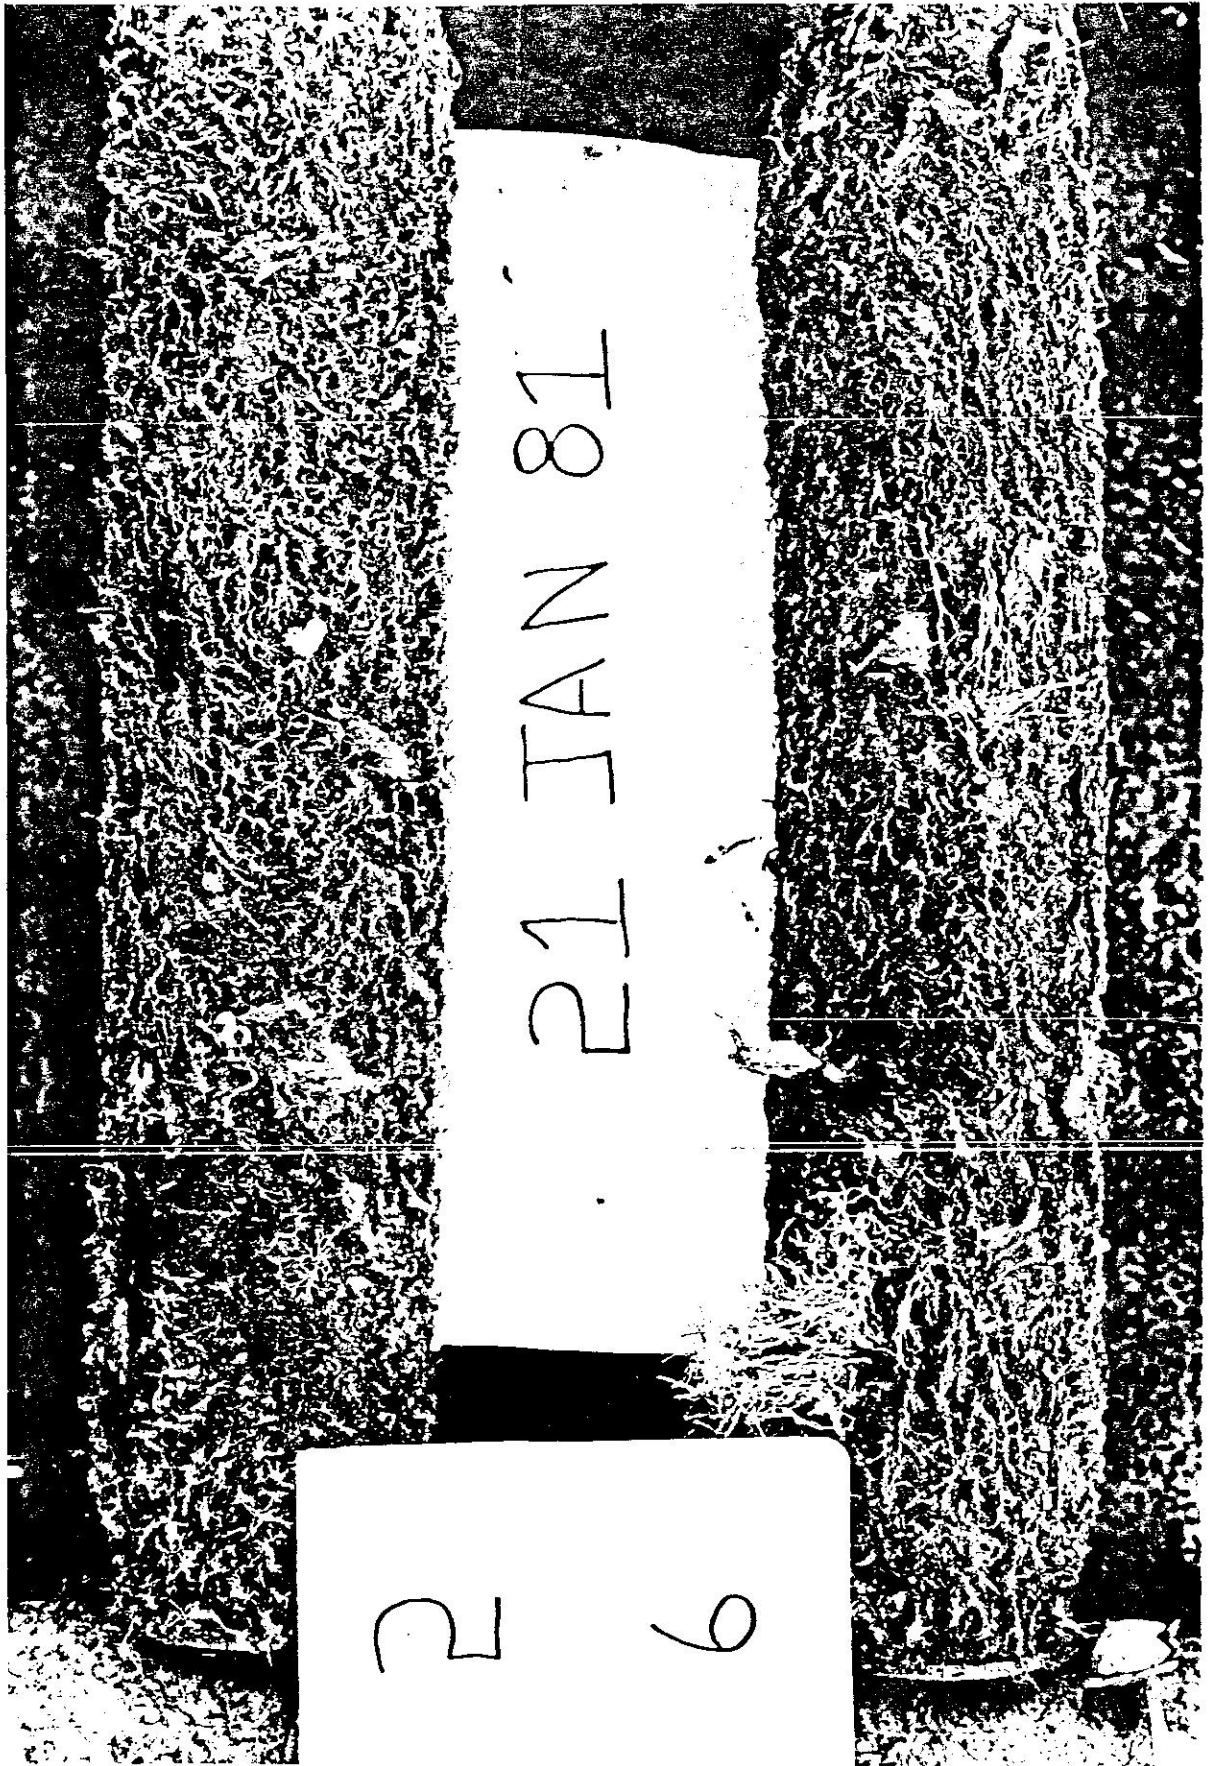
(1") SAMPLE #	(1 1/4") EROSION	(1 1/4") CORROSION	BIOFOULING
2	None	None	See Detailed Analysis
6	None	None	" " "
10	None	None	" " "
14	None	None	" " "
21	None	considerable pitting	} amphipod Podocerus <u>Stenothoe</u>
24	None	cover gone considerable pitting	
28	None	None	See Detailed Analysis
120	None	None	" " "

hydroid	100% cover
<u>Halocordyle</u>	
<u>Obelia</u>	
sponge	few per sample
<u>Scypha</u>	
serpulid worm	few per sample
<u>Filograna</u>	
<u>Hydroides</u>	
bivalve	occasional
<u>Atrina</u>	
gooseneck barnacle	occasional
<u>Lepas</u>	
amphipod	several per sample
<u>Podocerus</u>	
<u>Stenothoe</u>	
<u>caprellid</u>	
ascidian	1 specimen
<u>Herdmania</u>
