ECOLOGICAL REVIEW OF
HYDROELECTRIC RESERVOIRS
IN PUERTO RICO

William R. Jobin, Frederick F. Ferguson,
and Raymond Brown

CENTER FOR ENERGY AND ENVIRONMENT RESEARCH
FORMERLY PUERTO RICO NUCLEAR CENTER: UNIVERSITY OF PUERTO RICO

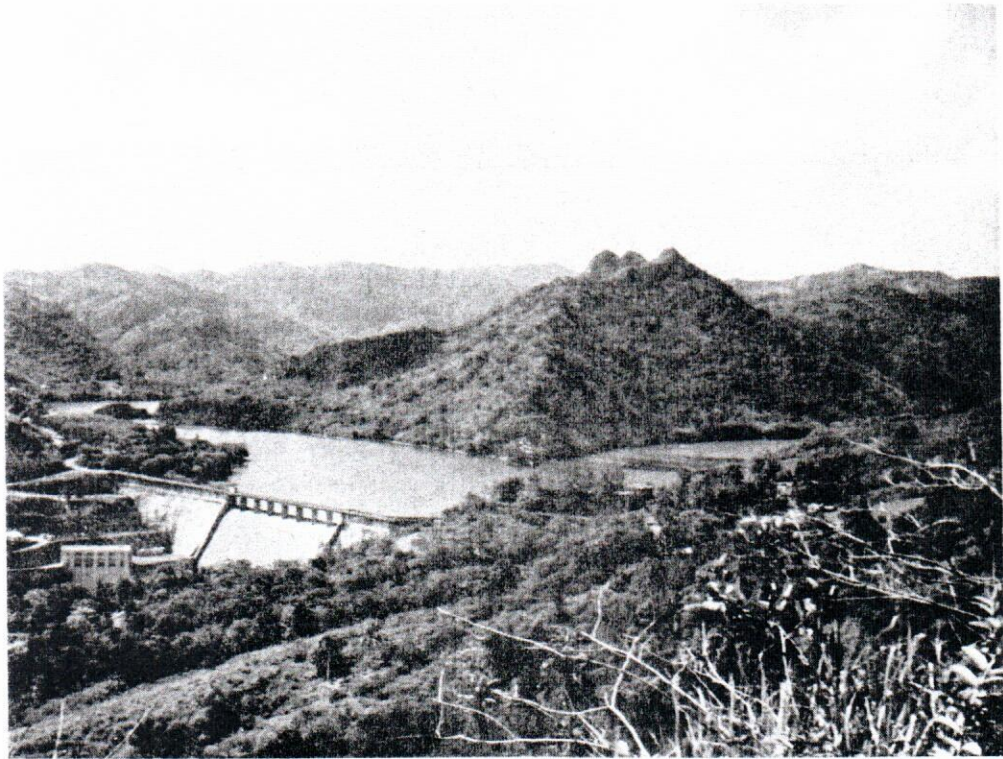
HYDROELECTRIC PLANT AT LAKE DOS BOCAS

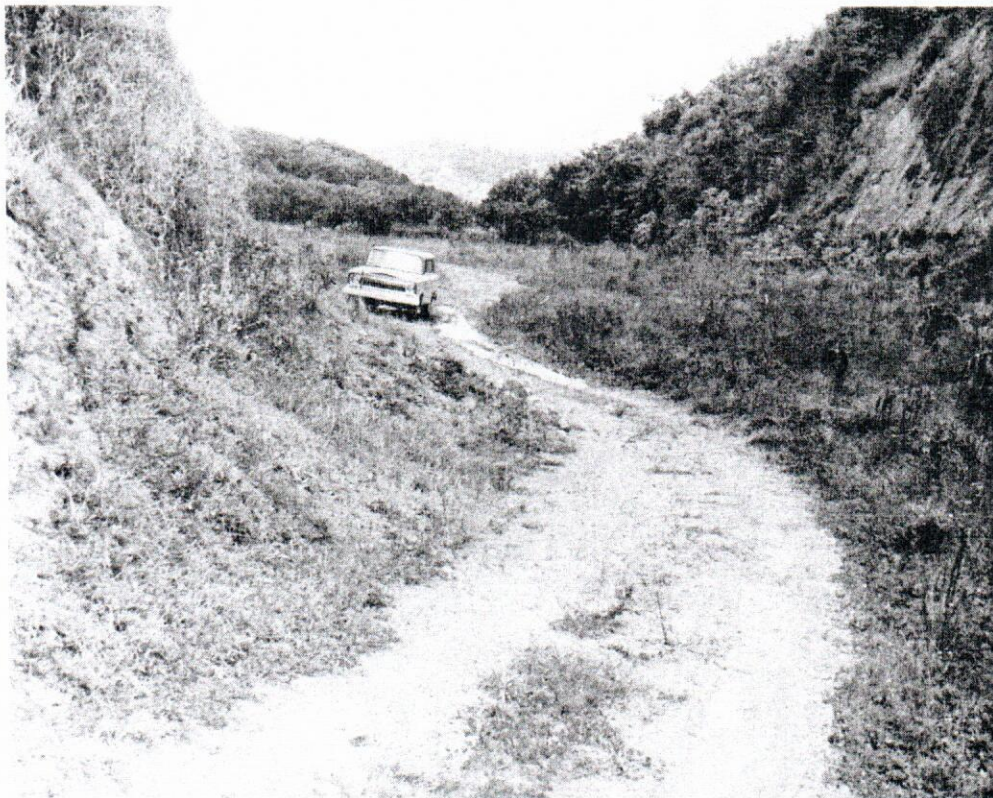
FIGURE 5

EMERGENCY SPILLWAY OF LAKE CARITE SHOWING SMALL SWAMP CONTAINING BIOMPHALARIA GLABRATA JULY 1976

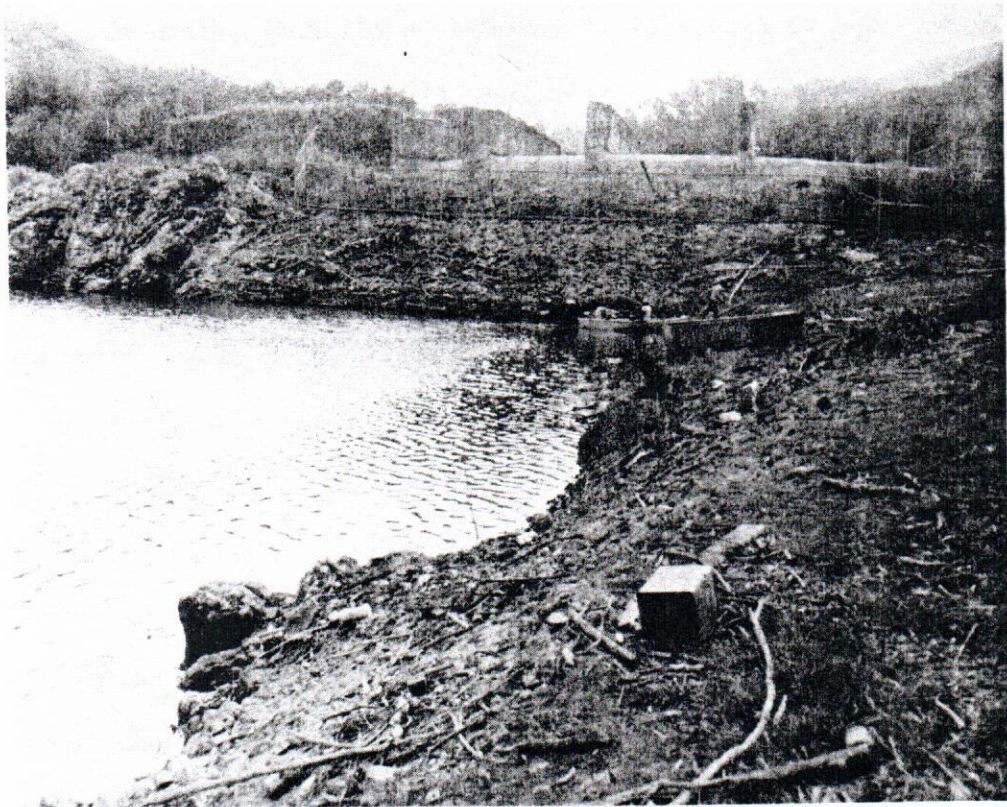
SPILLWAY OF LAKE GARZAS
